BACKUP INFORMATION

PREVIOUS FLIGHT ANOMALIES BACKUP

STS-105 IN-FLIGHT ANOMALIES BACKUP

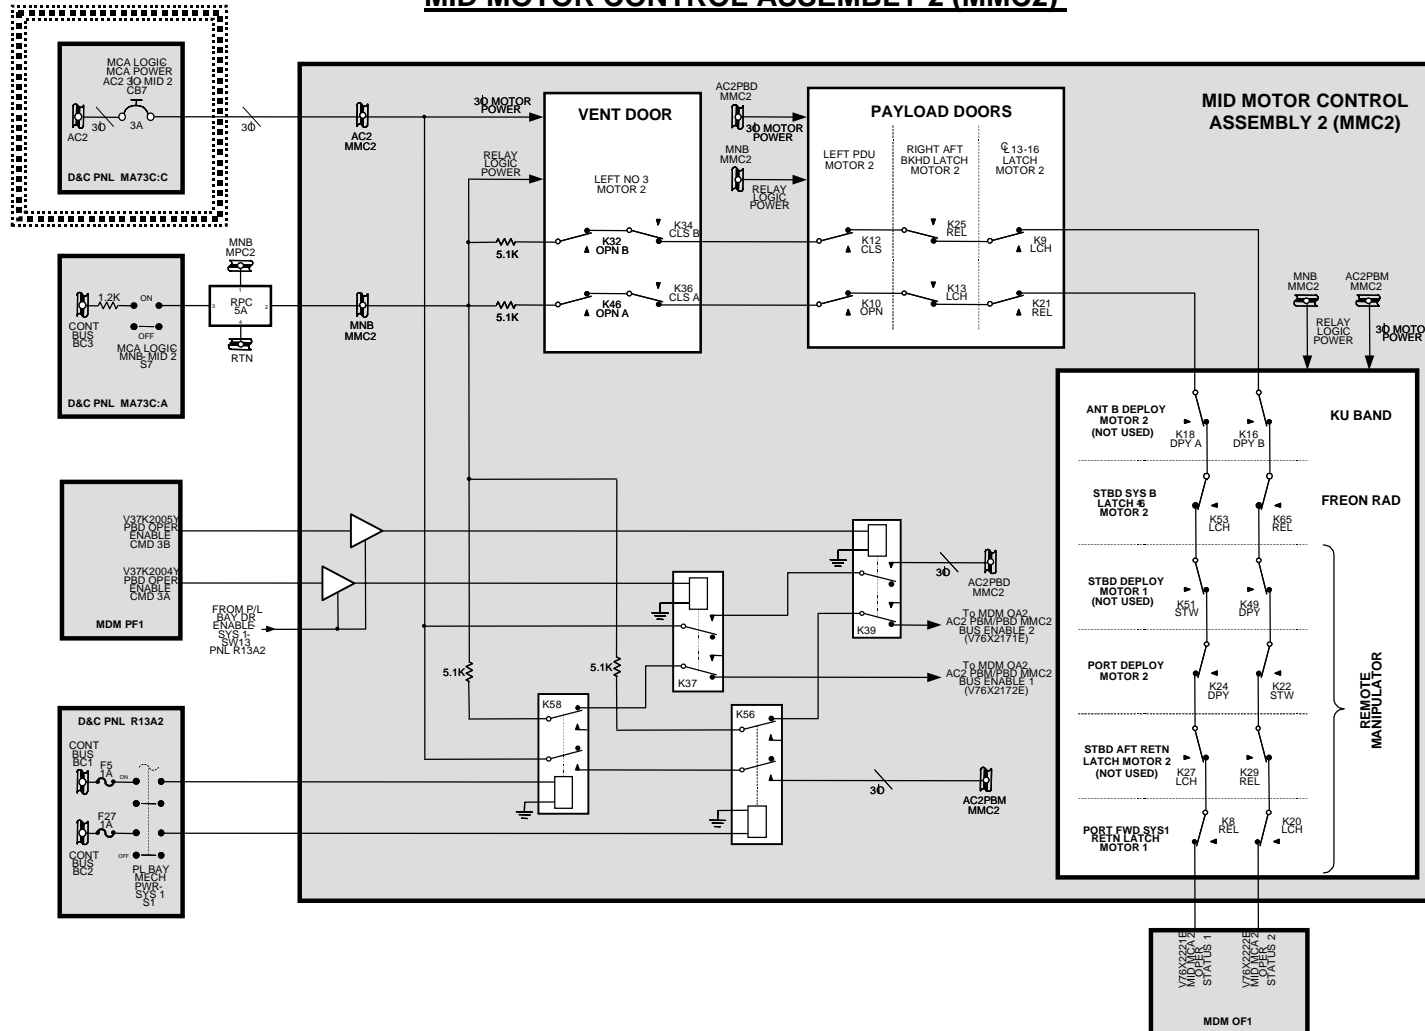
MID MOTOR CONTROL ASSEMBLY 2 (MMC2)

- The AC2 MMC bus provides power to various components, all of which were found to have phase A current missing after this point in time
 - Port payload bay door drive motor 2
 - Starboard payload bay door aft bulkhead latch motor 2
 - Payload bay door centerline latch 13-16 motor 2
 - Left vent door 3 motor 2
- All motors powered by the MMC2 AC2 are designed to operate on two phases
- A three phase ganged AC circuit breaker CB7 on panel MA73C provides protection to MMC2 AC2 power circuits
- Based on observed anomalies and circuit analysis, the most probable cause of this failure was believed to be a contaminated contact in the circuit breaker

- Post-landing KSC troubleshooting isolated the problem to the MMC2 AC2 power circuit breaker CB7 on D&C panel MA73C
 - Oxidation on the contacts has historically been the root cause of circuit breaker problems
 - The OMRSD provides for cycling the CB at least 5 times in an attempt to clean the contacts and clear the problem
 - Circuit breaker was cycled and phase 'A' was recovered with the second cycling of the breaker
- Decision made to remove and replace CB7 and perform failure analysis
 - Plan is to evaluate circuit breaker condition and evaluate and compare its condition to other recent circuit breaker failures
- D&C Panel MA73C is scheduled to be shipped to NSLD during OMM processing flow power down period

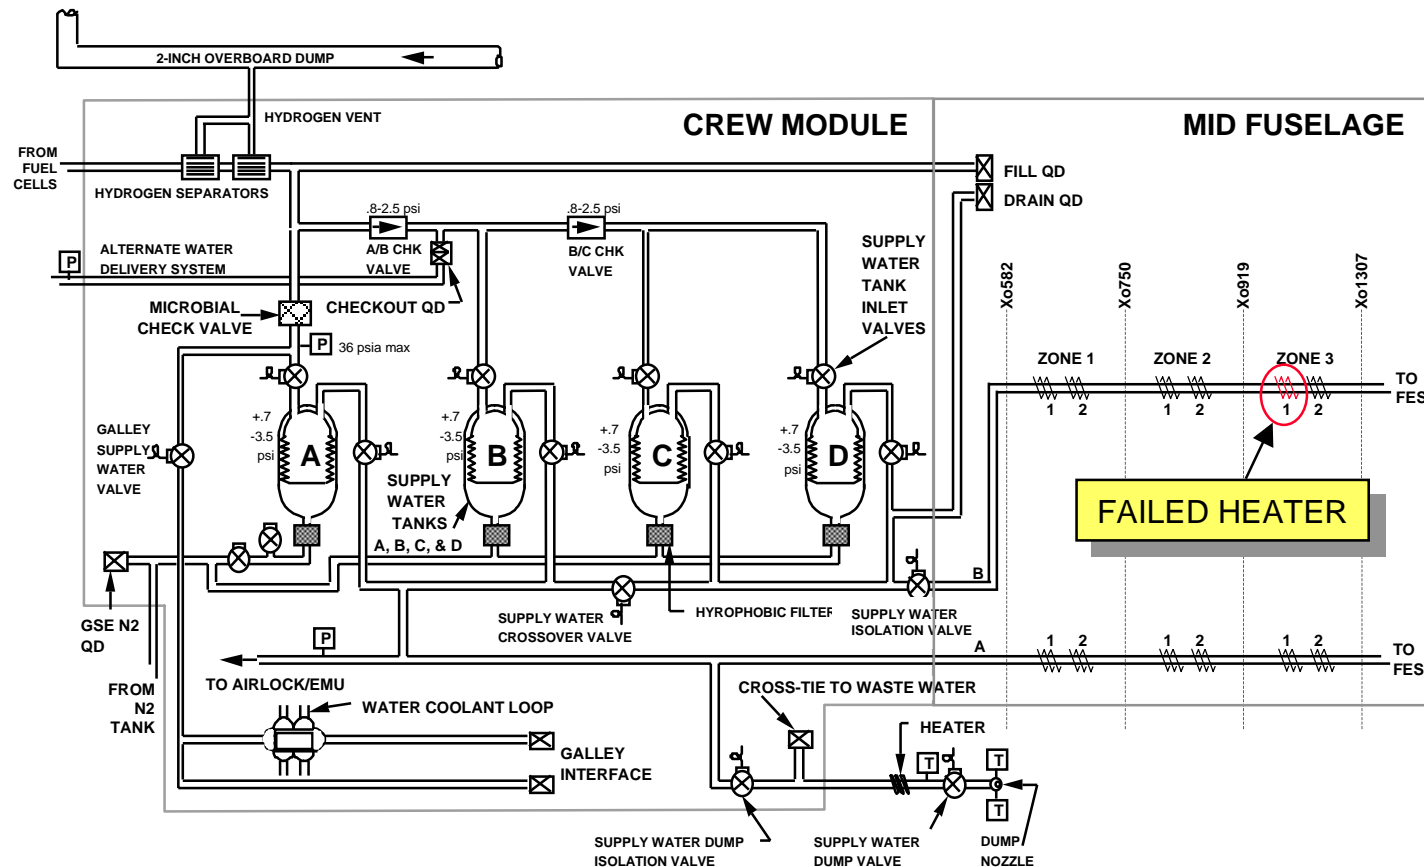
SUPPLY WATER SYSTEM

- Water line temperature (V63T1875A) in zone 3 drifted to around 52°F at MET 000:13:00 (vs 65°F to 90°F typical) indicating heater failure
 - No heater cycles seen following application of heater string 1 power post-launch
- Heater is required to prevent water line freezing
 - There are two heater strings per feedline
- Heater string 2 was enabled at MET 000:17:20 and system performed nominally
- A contingency line purging procedure was in place in the event of a second heater string failure

- Post-flight troubleshooting found a broken wire at the heater ground point
- Ground wire was repaired and the heater string successfully retested

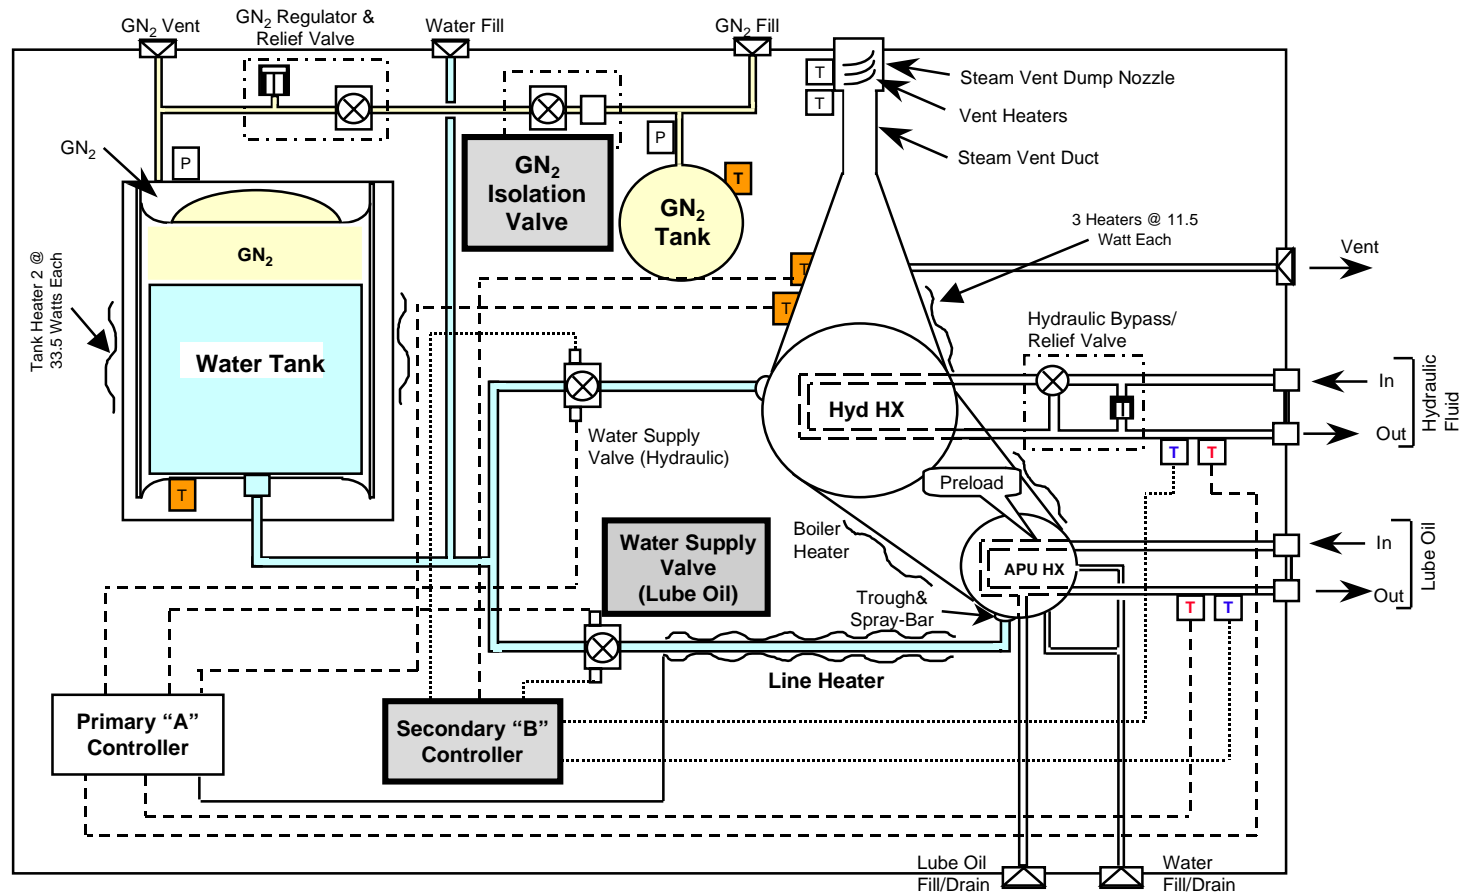
WATER SPRAY BOILER SYSTEM SCHEMATIC

- Post-flight troubleshooting isolated the source of the heat to the GN₂ isolation valve
 - A failure within the “B” controller (S/N 37) caused the isolation valve to remain powered and act as a heater, supplying 37.5 watts of electrical energy
 - GN₂ iso valve temperature increased from 73°F to 156°F in ~ 2 hours in atmospheric environment
 - Multiple single point failures within individual controllers can produce this failure
- Flight failure scenario simulated utilizing a spare GN₂ iso valve in a thermal / vacuum test
 - Valve outlet port temp increased from 70°F to 225°F in ~ 2 hrs
 - Analytically it was determined that this would correlate to a coil “B” temp of ~ 330°F

- The S/N 37 controller was removed and routed to NSLD for TT&E
 - The failure was isolated to circuit board # 8 (S/N 50) as the cause for the continuous power output to the GN₂ iso valve
 - Circuit board S/N 50 was removed/replaced with S/N 93
- Controller S/N 37 subsequently passed ATP and was reinstalled on OV-105 as the WSB 3B controller
 - Controller passed on-vehicle OMRSD checkout
- Testing / failure analysis of the failed circuit board revealed that capacitor C807 had experienced a high current leakage failure
 - The failed capacitor was removed and sent to NSLD for destructive analysis to determine the cause of failure

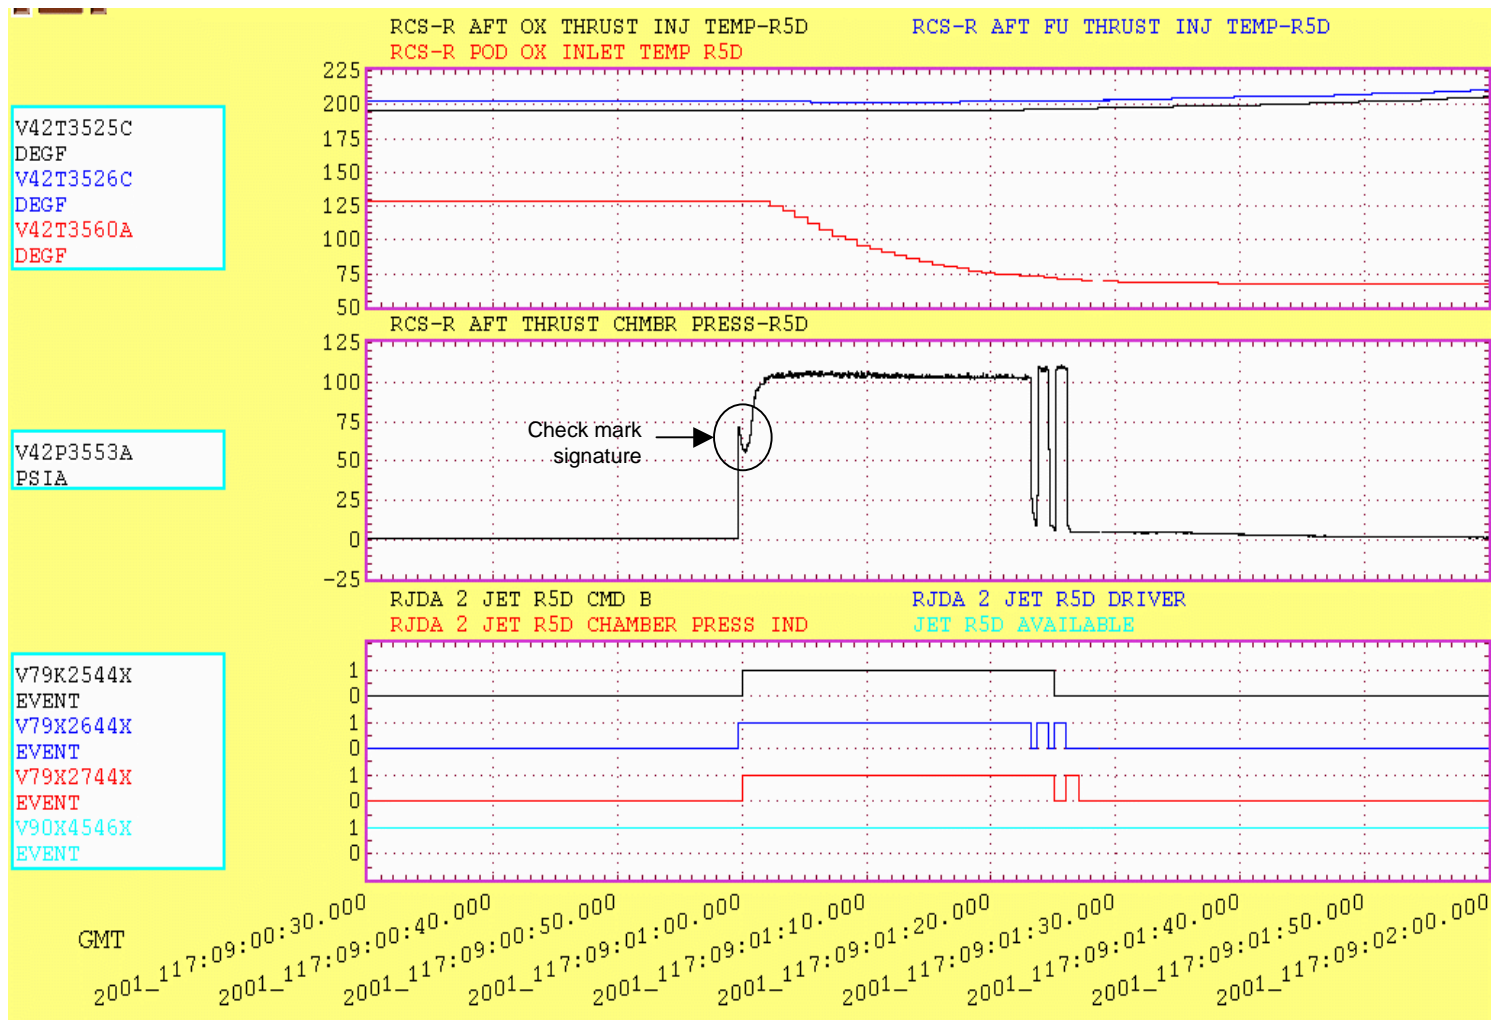
STS-100, R5D Firing After 72 hr Quiescent

- The R5D low-Pc occurrences were caused mainly by hot propellant based on flight and test data
 - Not a concern for valve or thrust chamber degradation
 - Did not adversely effect overall thruster functionality
- R5D's Pc appeared to be more sensitive to hot propellant than L5D, even though oxidizer inlet temperatures averaged higher on L5D
 - It is possible that the extruded fuel valve seal contributed more variability in Pc response
 - Both at higher inlet temperatures and, to a lesser degree, at nominal inlet temperatures
- Effect of low-Pc on thrust chamber
 - Presence of low-Pc will not affect the integrity of a VRCS thrust chamber

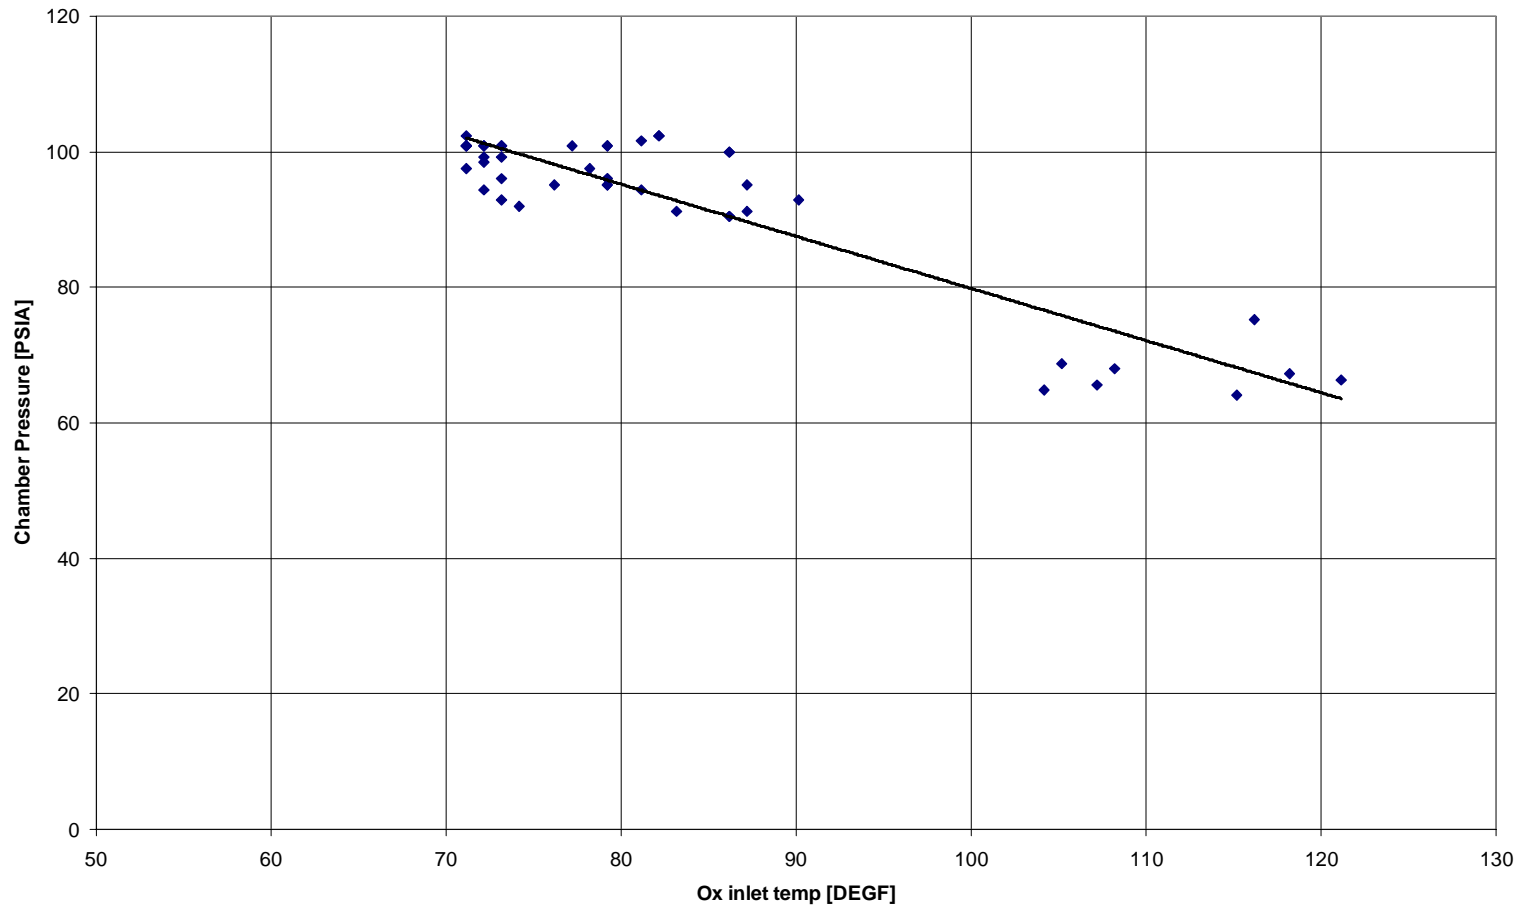
STS-100, Day 119, R5D Chamber Pressure vs. Ox Inlet Temperature

- Effects of hot propellant on VRCS thruster operation
 - WSTF and Marquardt test data shows that P_c , mixture ratio (MR) and specific impulse decrease as prop temperature increases
 - P_c traces become erratic at higher propellant temperatures
 - “Check mark” signature occurred sometimes, on longer pulses (1-5 secs) similar to those observed on STS-100
 - With hot propellant present, P_c was initially low but tended to approach nominal on longer firings
 - No valve or thrust chamber problems or degradation were noted from WSTF and Marquardt hot propellant tests
- Worst case effect of low P_c on VRCS thrusters
 - Due to low MR, reduced oxidizer flow - efficiency decreases but thrust chamber wall temperatures are much higher than at nominal MR
 - Not a flight concern - Marquardt low MR tests showed no thrust chamber or valve degradation after numerous pulses and seconds of burn time

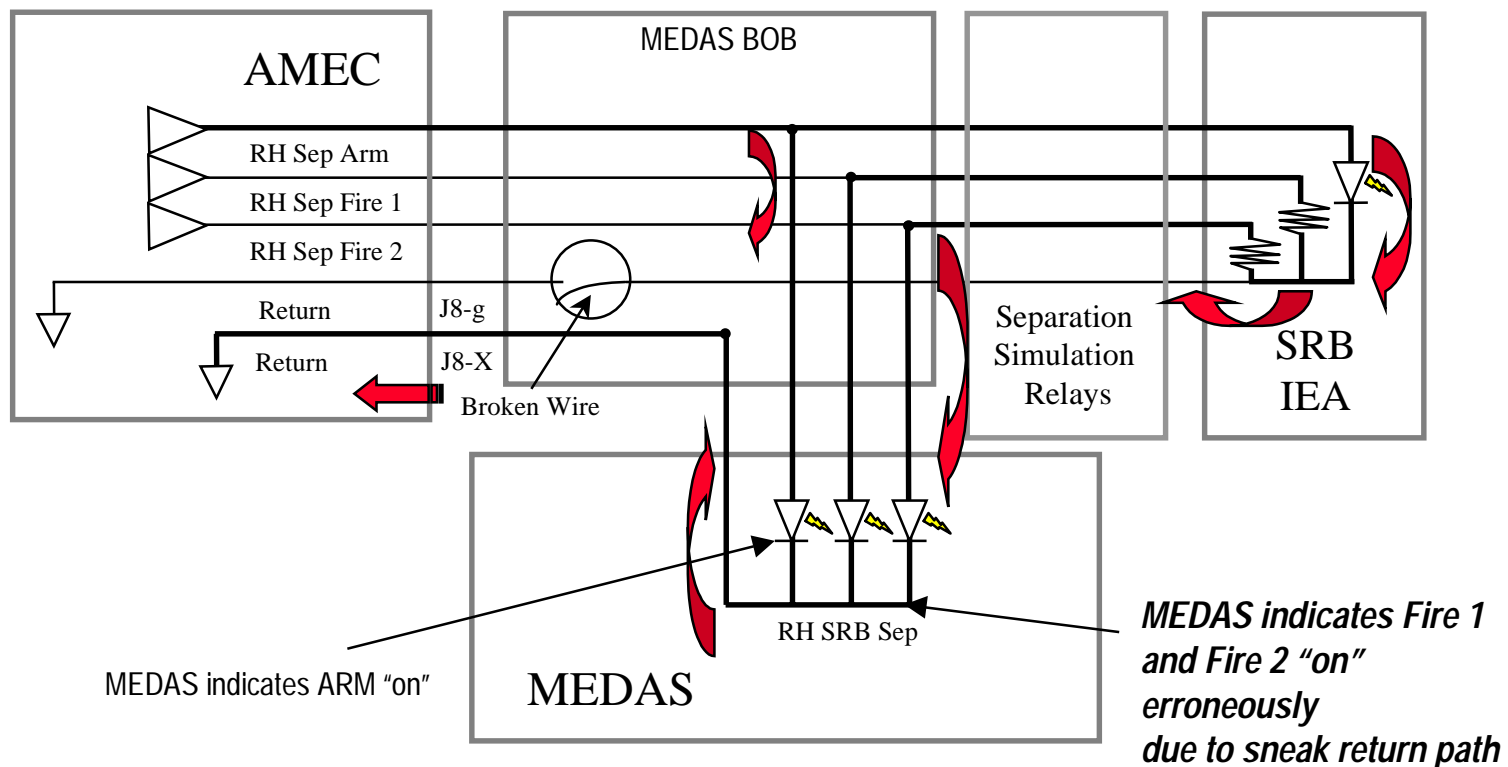
Typical Sneak Signal Return Path - Simplified Diagram

No.	Description	S/N	Findings	Causes
1	Right SRB SEP Fire 1 and Fire 2 turned on at the same time the ARM command turned on.	3	Confirmed MEDAS BOB J8 pin g broken wire (Right SRB SEP return pin) - Sneak path between IEA and MEDAS.	SAIL Instrumentation
2	Right SRB SEP PICs (6) did receive ARM command but did not receive Fire 1 or Fire 2.	3	Confirmed MEDAS BOB J8 pin g broken wire (Right SRB SEP return pin) - Sneak path between IEA and MEDAS.	SAIL Instrumentation
3	MEDAS showed AMECs intermittently did not generate ET/ORB FWD Fire 1 command	2, 5, and 8	Confirmed a bent pin on SAIL MEDAS patch panel.	SAIL Instrumentation

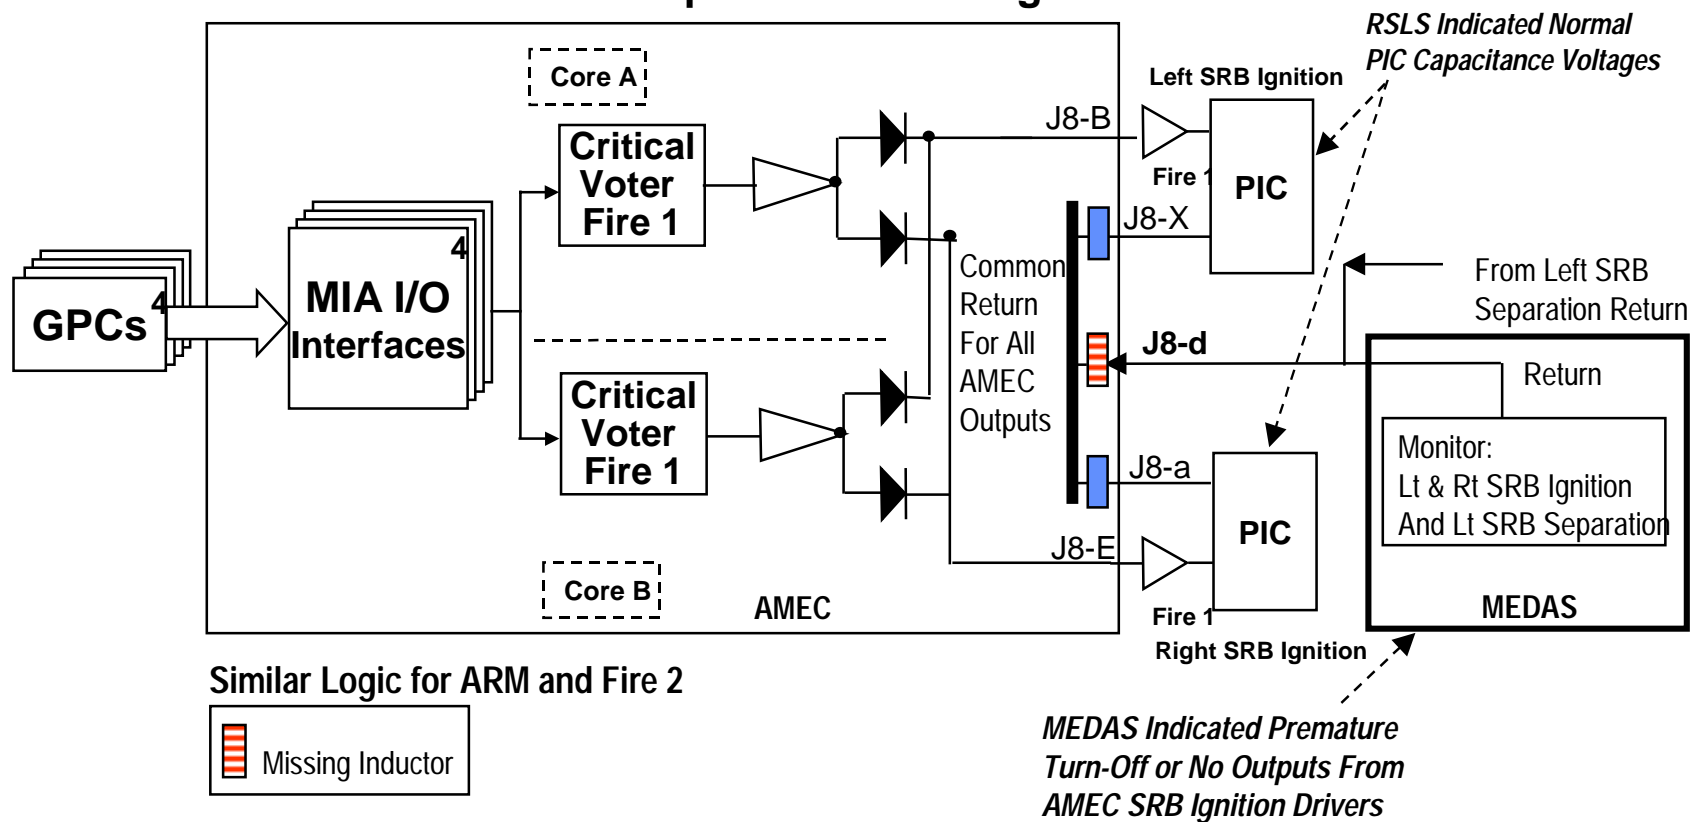
AMEC Fire 1 - SRB Ignition and MEDAS Instrumentation

No.	Description	S/N	Findings	Causes
4	Left SRB IGN PIC ARM turned off prematurely. Left SRB IGN Fire 1 did not turn on. Left SRB IGN Fire 2 did not turn on. Right SRB IGN ARM turned off prematurely.	10	Confirmed open ground pin J8-d failure on AMEC 10. Confirmed Unique SAIL instrumentation (MEDAS) uses AMEC J8-d as reference for these four left and right SRB IGN signals. Confirmed missing ground path inductors within the AMEC S/N 10.	Loss of signal returns within the AMEC S/N 10. Confirmed that missing inductors is an isolated event and inspection escape which occurred during the initial manufacturing activities.
5	Left SRB SEP Fire 1 and Fire 2 turned off prematurely.	10	Confirmed open ground pin failure on AMEC S/N 10.	Same as problem 4.

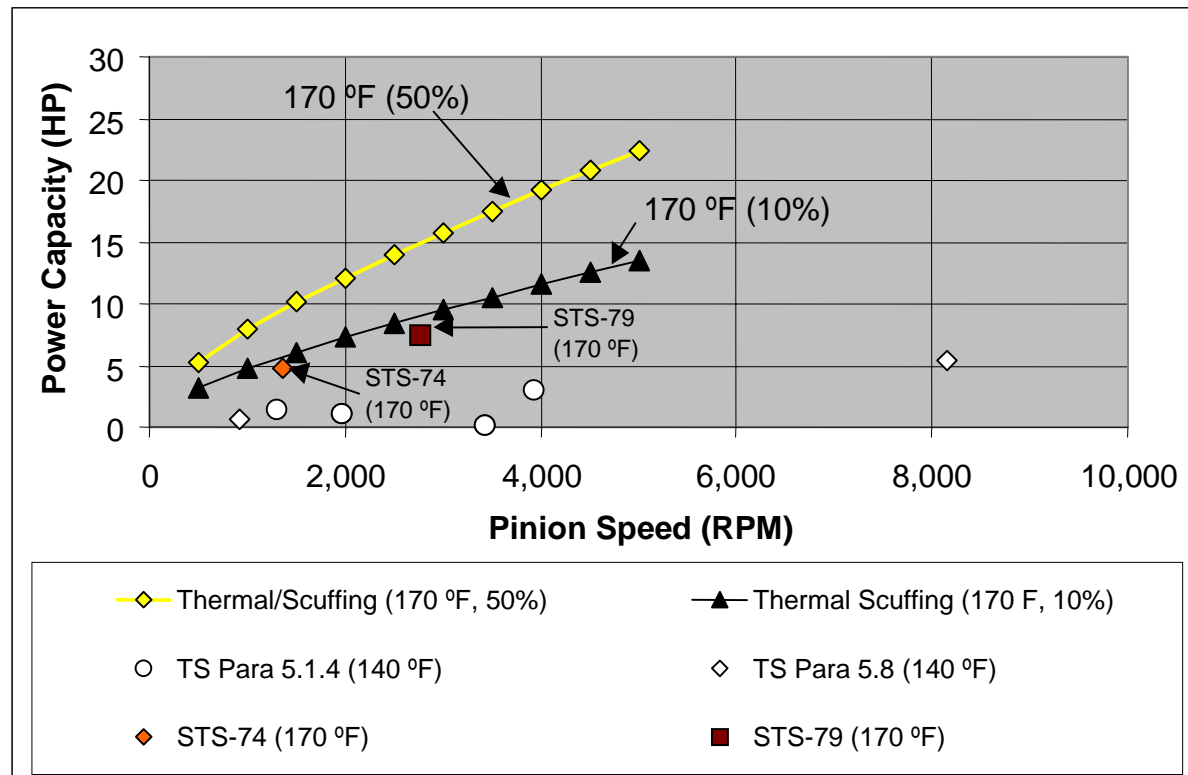
System 2 Backdriving Probability Analysis (Steady-State STS-74, STS-79, ATP)

- Scuffing limits for 10% & 50% probability assuming a 170 °F bulk temp
- Scuffing design limit 50% probability

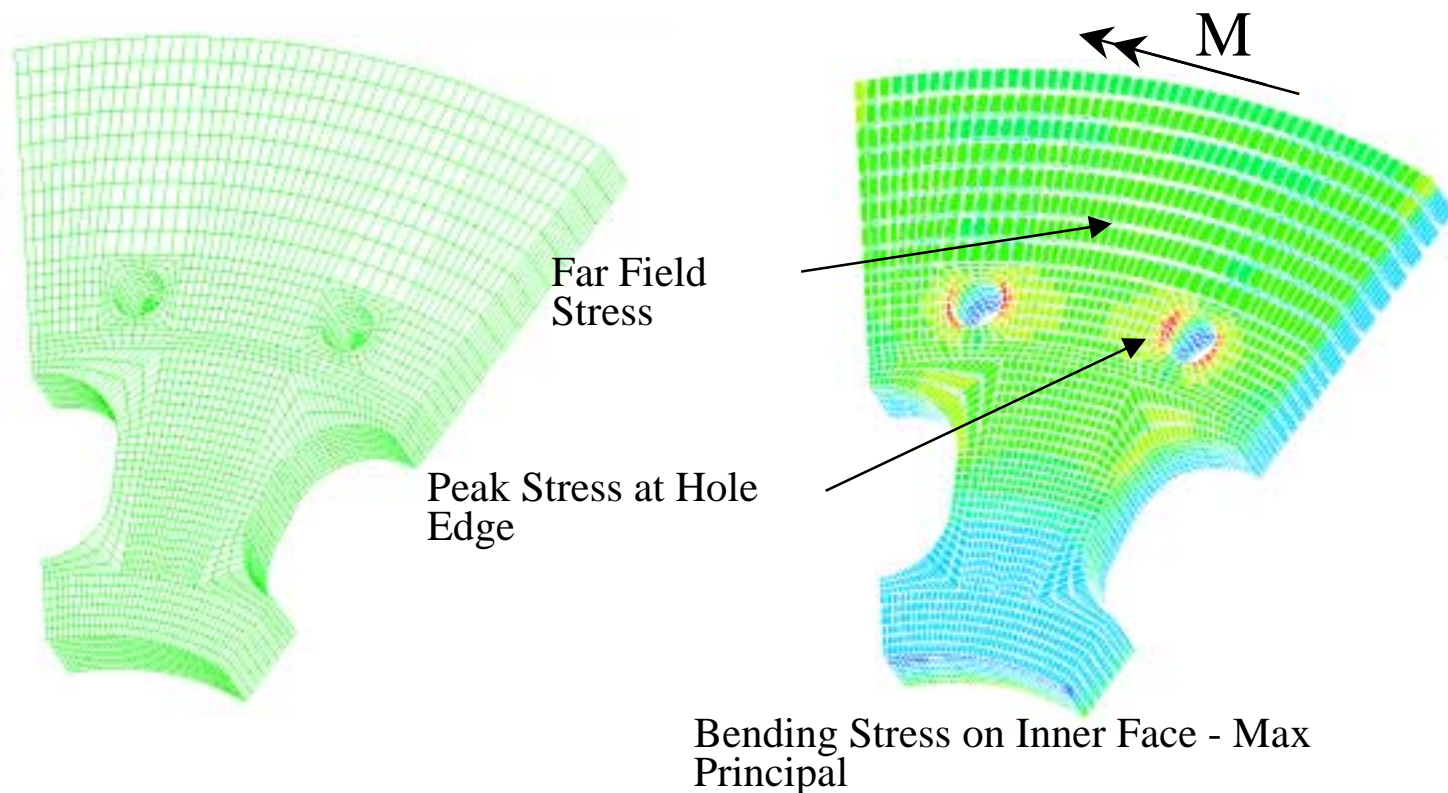
- Built simplified finite element model of segment of wheel, including spoke cut-outs
- Stress patterns examined to determine ratio of far field to peak stress at hole edge, and gradient between holes
- Bending stress distribution shows ~2.3 ratio

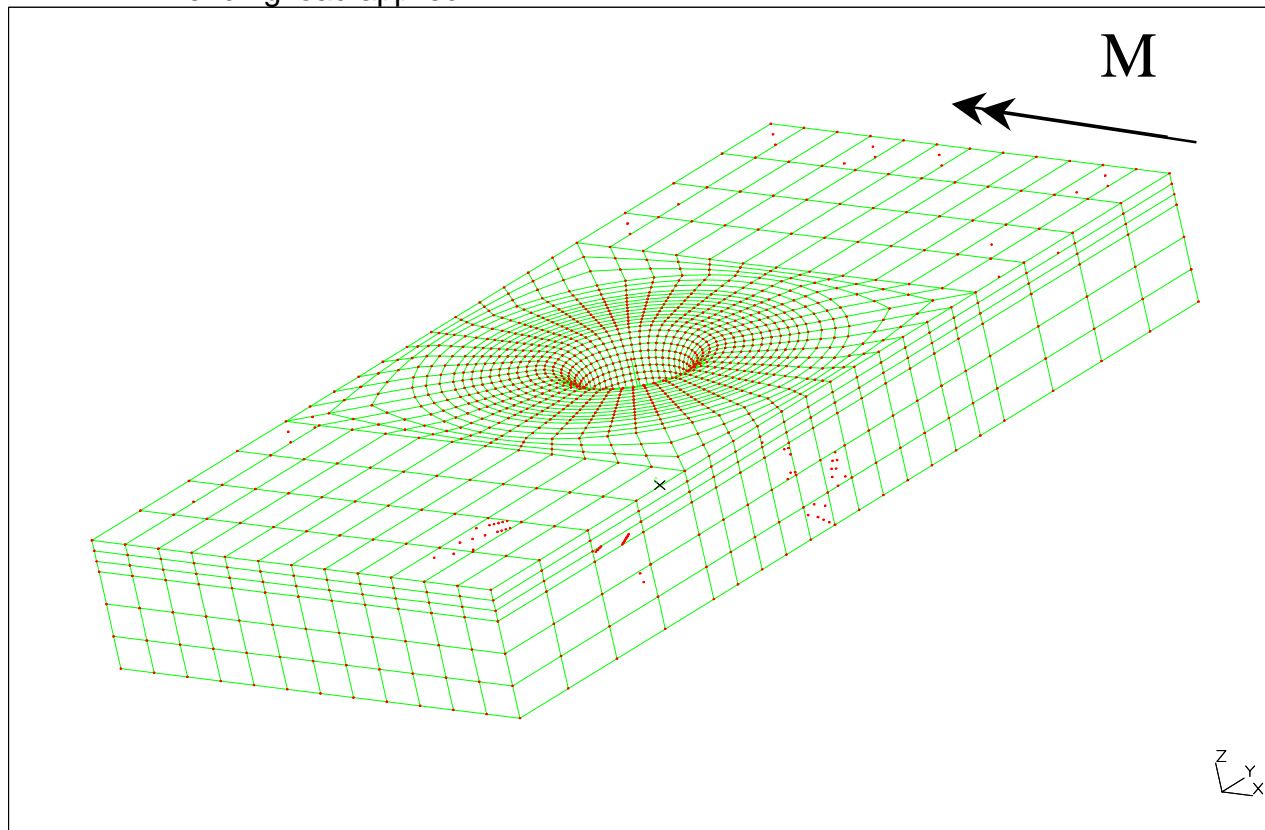
Locate Peak Stress on Hole Edge Radius

- Hole edge at inner face of wheel has 0.25 inch radius
- Built very simplified model of single hole including edge radius
- Bending load applied

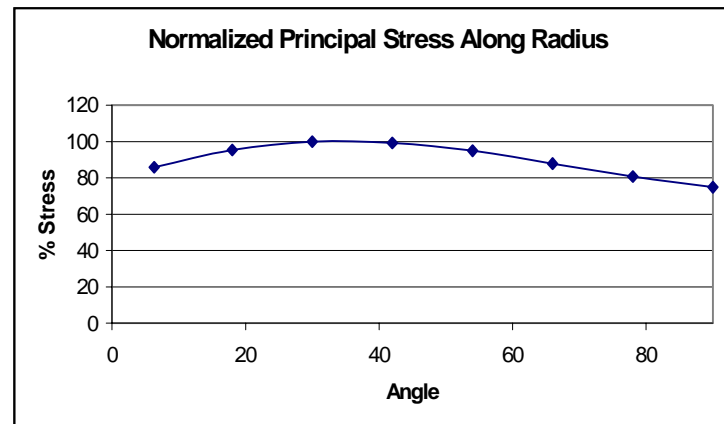
Cross Section Through Hole

Principal Stress Peaks at ~30° Up on Hole Edge
Radius
